DANCING WITH DANGER

A California contractor uses a PVC alloy pipe to reline a culvert without disrupting the main freeway between San Francisco and Sacramento

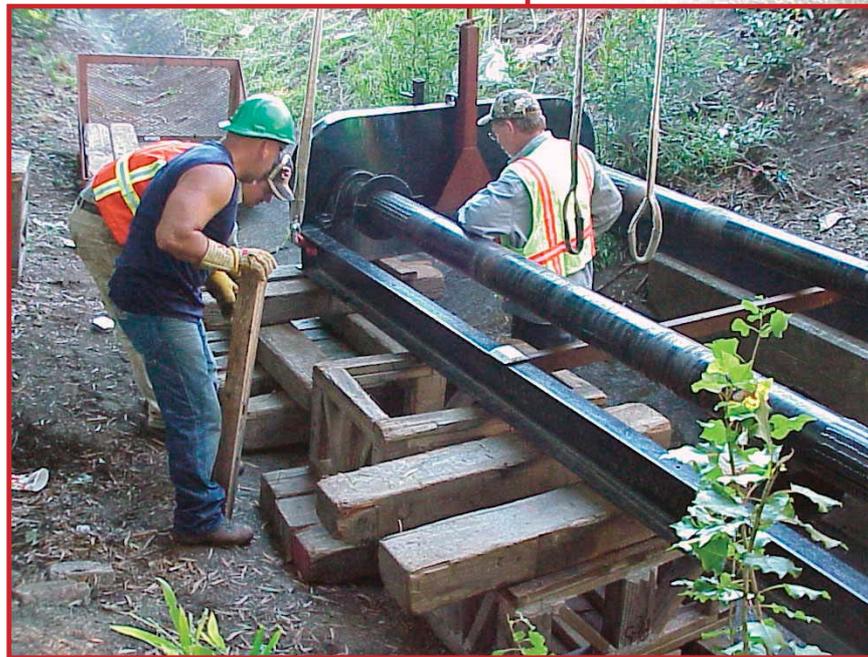
UltraLiner representative Lee Trotter (right) oversees building the cribbing and special rollers for launching the liner.

The liner, coiled in an H pattern, was almost flat. To help it navigate the 90-degree bend in the manhole, Miksis mounted a 6-inch by 3-foot-tall roller with a 2-inch axle and 2-inch bearing blocks to the inside corner of the manhole. The roller lay on its side. The cable was attached to a 30,000-pound Skagit double-drum yarder powered by a 1952 flathead Ford engine. “I never could have done this job without that logging winch,” says Miksis. He positioned it at the daylight inlet.

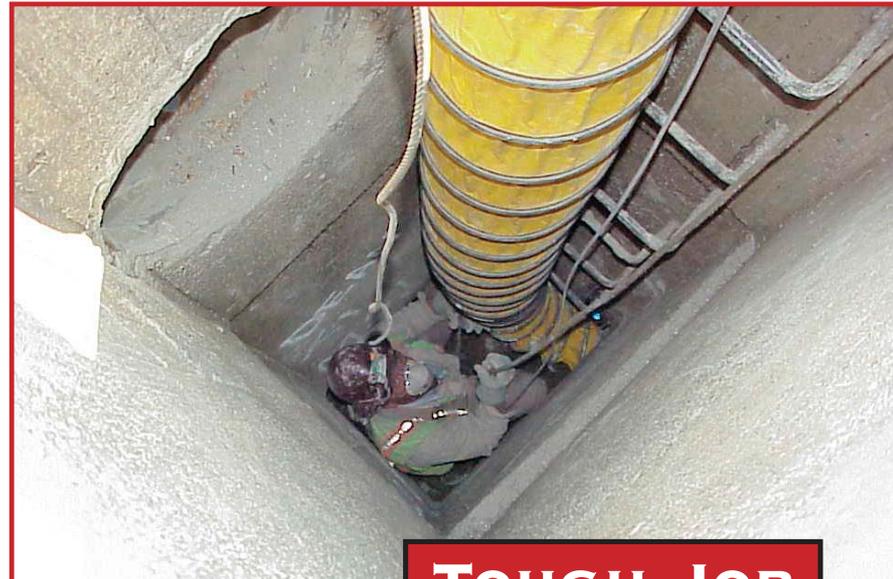
Crouched in the drop inlet, Gary Miksis slogs concrete batch mix to Salvador Galindo, who is inside the 24-inch culvert.

packed 10 yards of concrete. (Where applicable, Miksis personnel followed OSHA confined-space procedures to the letter.) "We devised a skid system and slid square trays of lightweight mortar through the drop inlet," says Miksis. "We hand-mixed the concrete on the shoulder of the freeway."

For three weeks, Galindo folded the mixture of cement, fly ash, and vermiculite into the residual water running beneath the pipe. As he reinstated the invert, groundwater began flowing through the culvert again.

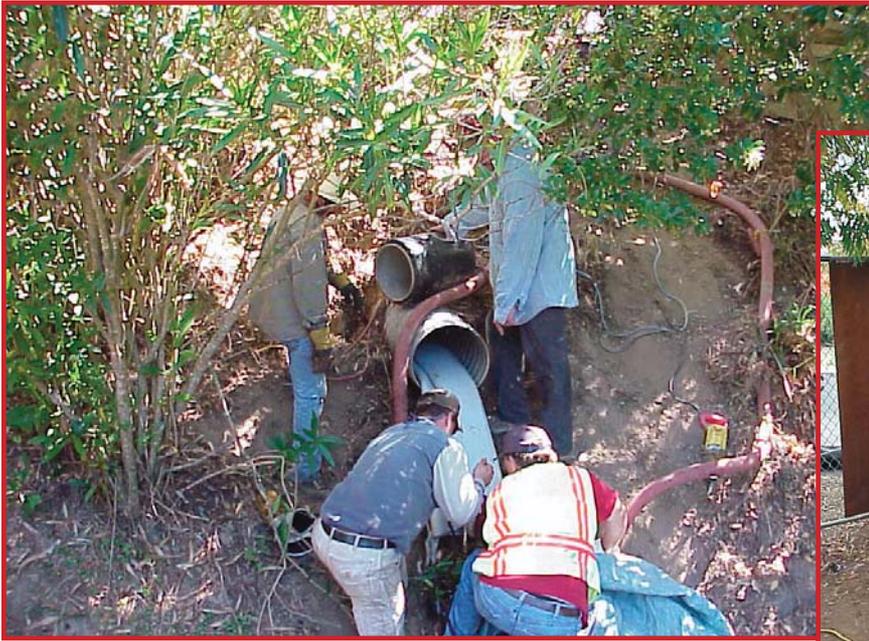
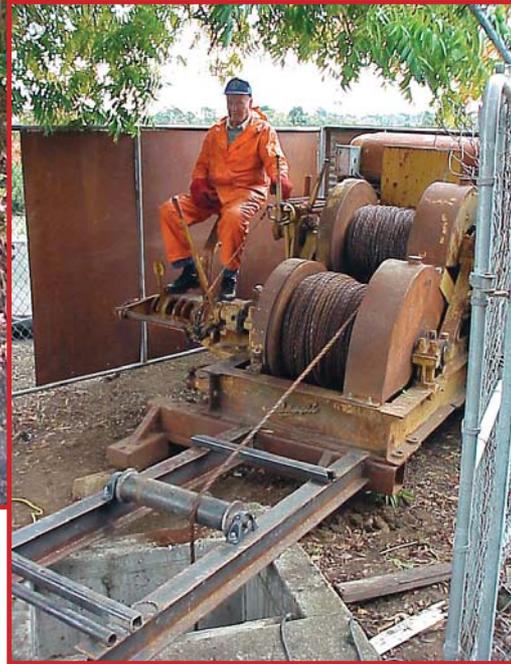
Above, feeding the liner into the culvert. At right, an old 30,000-pound logging winch was crucial to completing the pull.

The crew covered the wooden spool with a tarp, inserted a steam manifold, and heated the 500-foot-long liner for six hours. “It’s a hot medium, so we work fast,” says Miksis. “Once the liner cools down, the pull is over.” When the liner was flexible enough, the tarp was removed and the winch started.

The spool, mounted on a frame with four rollers, sat in a cradle. As the liner winched along, the men turned the rollers to help drive the spool and reduce friction. The pull progressed at 30 feet per minute. Sixty feet from the daylight inlet, the liner had cooled too much and the operation ceased at 8 p.m.

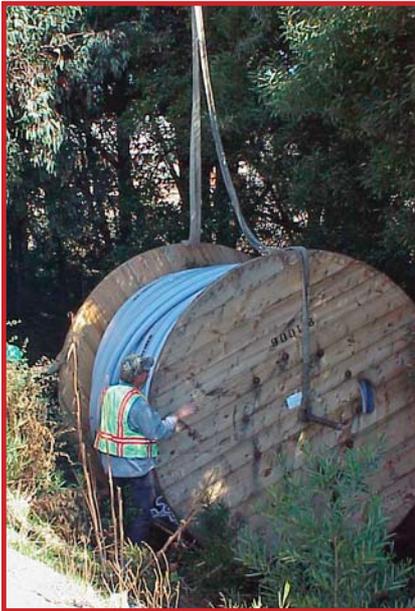
The folded UltraLiner and its 8-foot-tall wooden spool weighed a combined 16,000 pounds.

Once the washout was repaired, the culvert was televised again to determine its length, and then the custom PVC alloy pipe was ordered. The folded UltraLiner pipe on its 8-foot-tall wooden

spool weighed 16,000 pounds. Traffic control closed the eastbound ramp while the spool was set in position beside the concrete drop inlet.
