May 15, 2013

Inspection camera aids tricky pipe rehab project

BY: MARY SHAFER

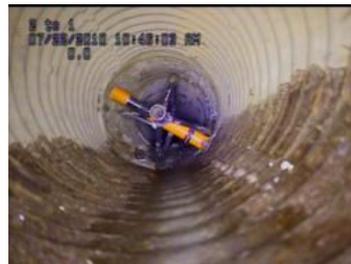
The pipejack

Miksis decided that a Porta-Power hydraulic jack would do the trick, but how to get it into place? They built a football-shaped skid and pushed it into place with 41/40 rigid steel sewer rods connected and extended as needed.

It took several hours to create the carrier on a shop workbench—designing, cutting and welding the 10-in.-tall carrier on a roughly 2-by-3-ft base with a push shoe. The jack head was about 1.5 in. in diameter on a 4-in. diameter base about 9 in. tall. It was mounted sturdily to the carrier and its 10-ft hydraulic fluid hose connected using regular couplers to a .25-in. jetting hose for power. Once onsite, it only took about 10 minutes to move it into position and force the deformed corrugated host pipe back into place.

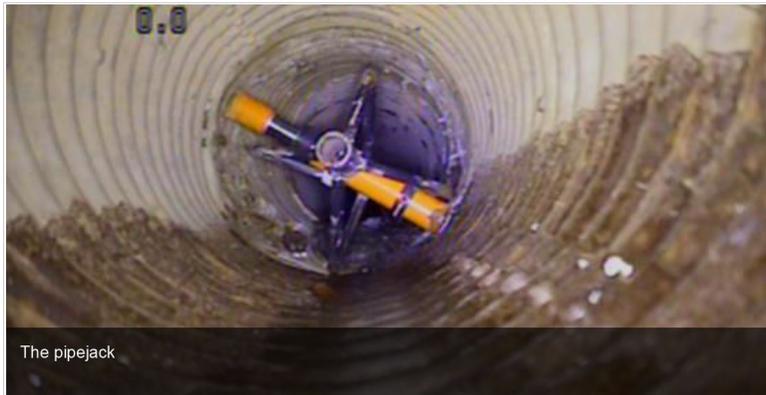
The pipejack
